PASSAIC RIVER BASIN
GOFFLE BROOK, BERGEN COUNTY
NEW JERSEY

MAPLE LAKE DAM NJ 00776

PHASE 1 INSPECTION REPORT NATIONAL DAM SAFETY PROGRAM

JULY 1981

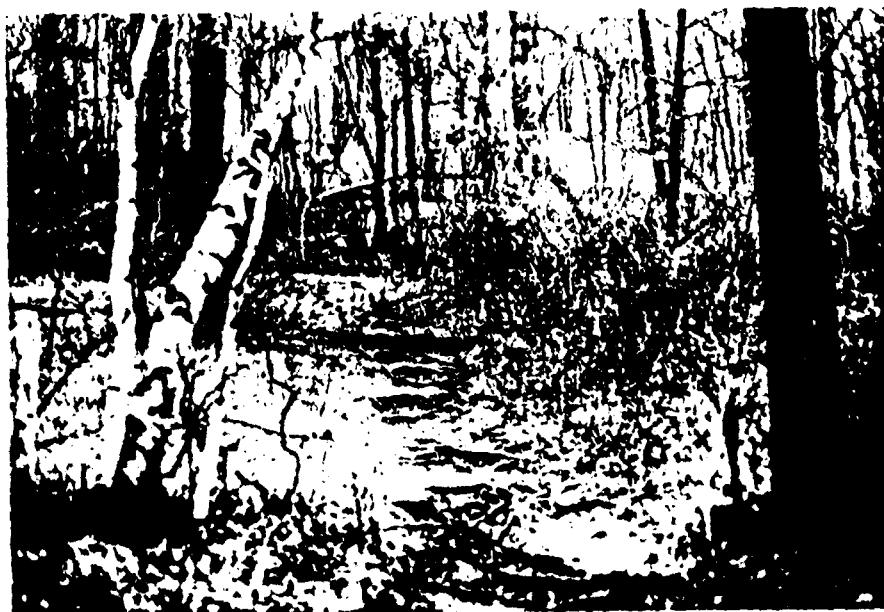
Trees growing on the upstream and downstream slopes of the embankment and in the area immediately downstream of the toe may blow over and pull out their roots or they may die with the result that their roots rot. In either case, serious seepage and erosion problems could result.

View of extensive root growth downstream of right side of dam.
